Electronic Liner Measurement Report

Job ID: 18-xxx

Vessel:	Vessel 1	Location:	Ijmuiden, Port Talbot, NL
Engine Type:	6 S70 MC	Job date:	
Engine ID:	☺	Service Engineer:	
Running hours:	43.081	Job order by:

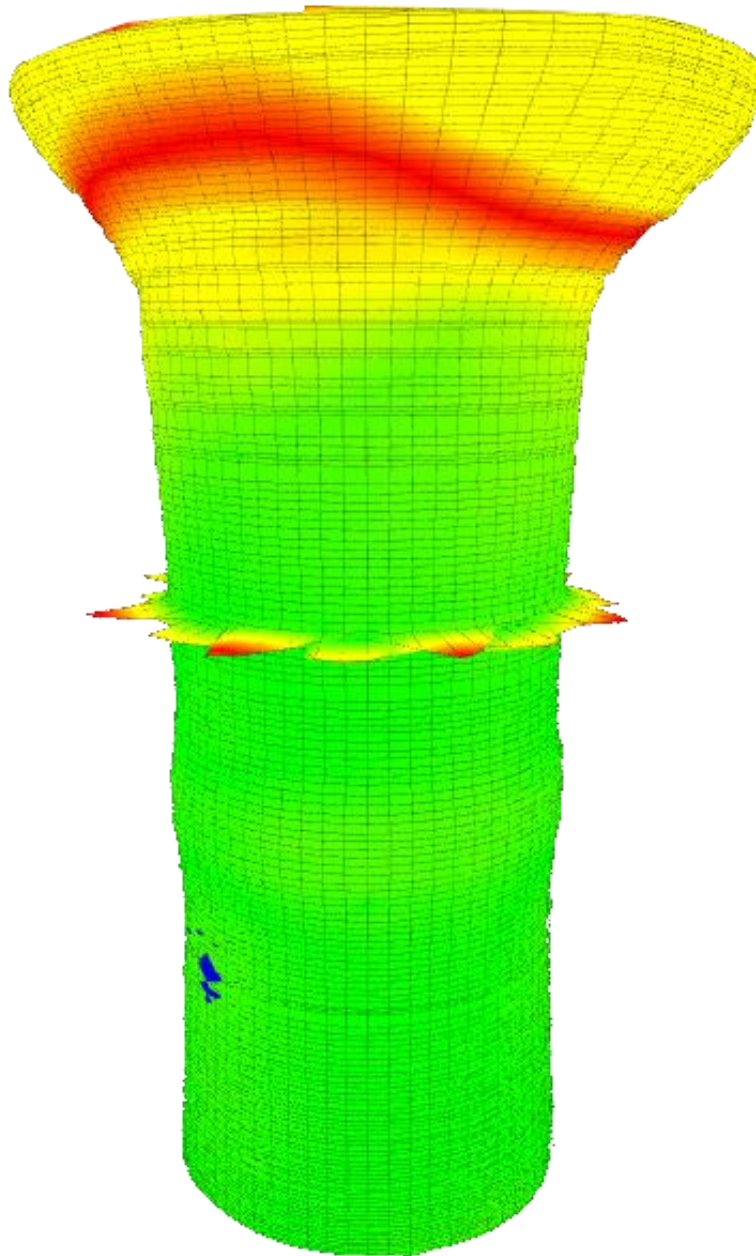
Liner1

The wear is smoothly increasing from BDC upwards. This is a sign of good cylinder lubrication performance and proper distribution.

All liners show very strong ovality in the upper 400mm stroke beyond engine makers recommendation. Worst case is liner 3 with 1.95mm ovality (recommended 0,7mm).

The increase in ovality is smooth and no sudden loads on rings are expected.

The strong ovality has negative impact on piston ring life time (increased fatigue) and piston ring grooves in piston crown (increased wear).

The ovality is expected to be partly wear and partly thermal distortion. We recommend to release the cylinder cover bolts to remove tension on liners and retighten them in proper sequence and torque.

We recommend re-measuring after this “relaxing” procedure.

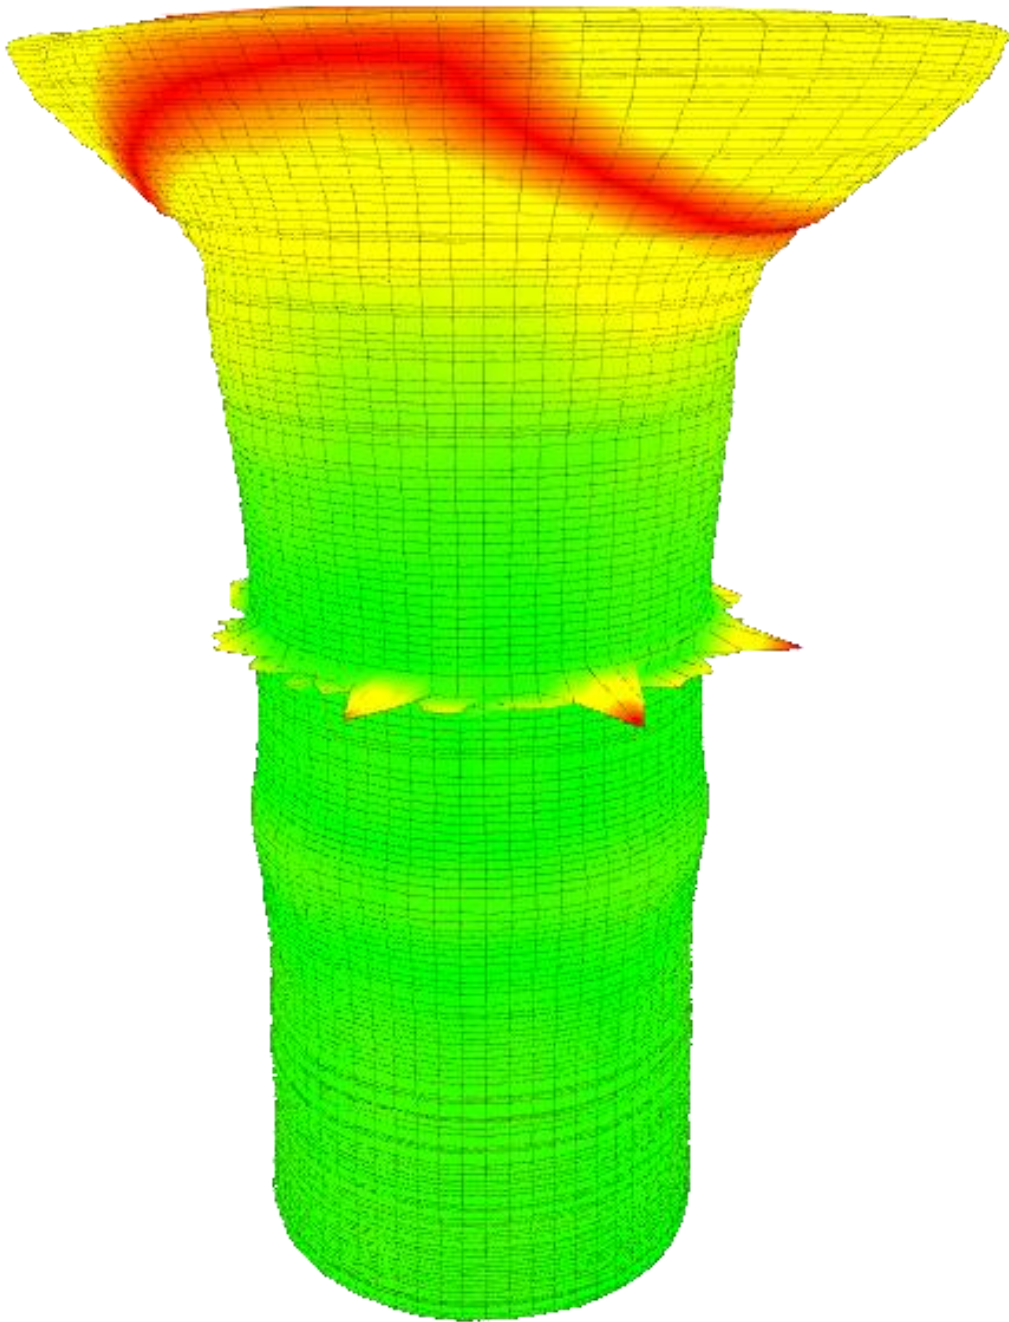
Liner 3

Liner shows local black patches in way of high wear area. This is considered a sign for the piston rings not properly pressing against the liner wall probably due to locally increased ovality.

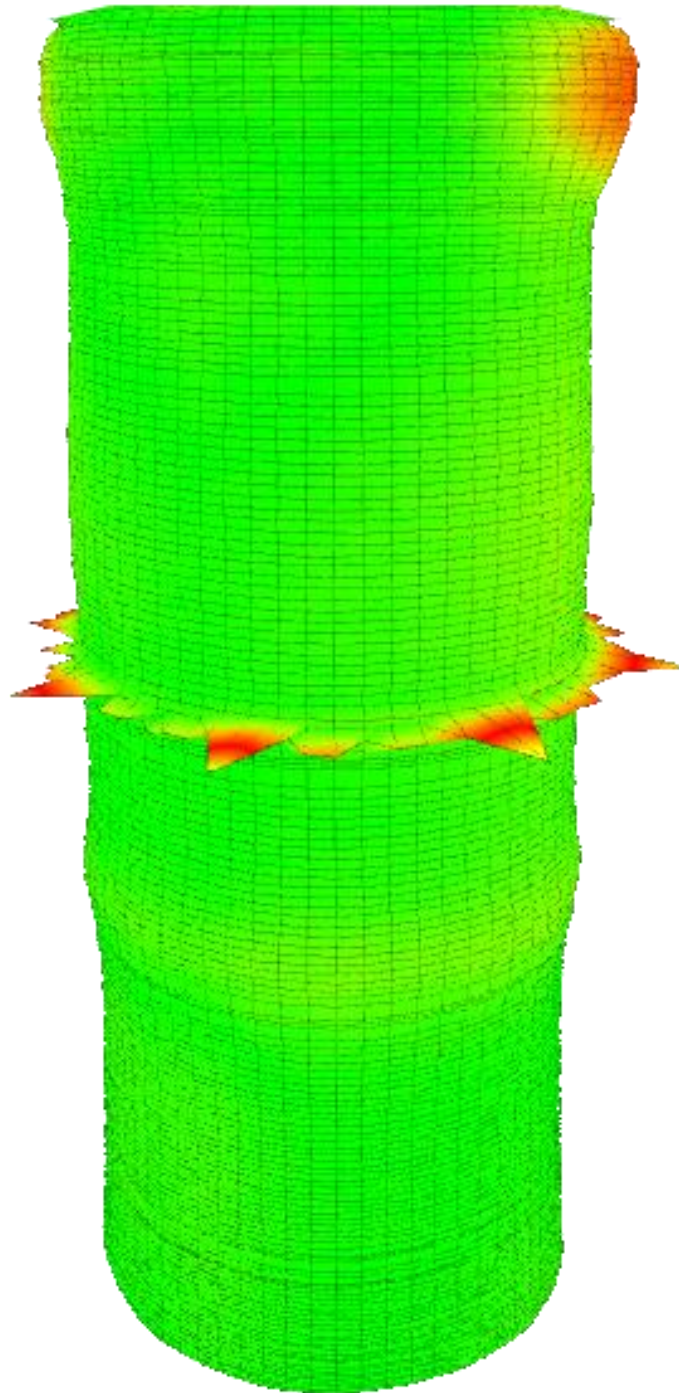
Liner 5

The wear pattern is that of a new liner and according the stated running hours.
