Electronic Liner Measurement Report

Job ID: 18-xxx

Vessel: Vessel 2	Location: Port Lemoine
Engine Type: 7RTA72	Job date:
Engine ID:

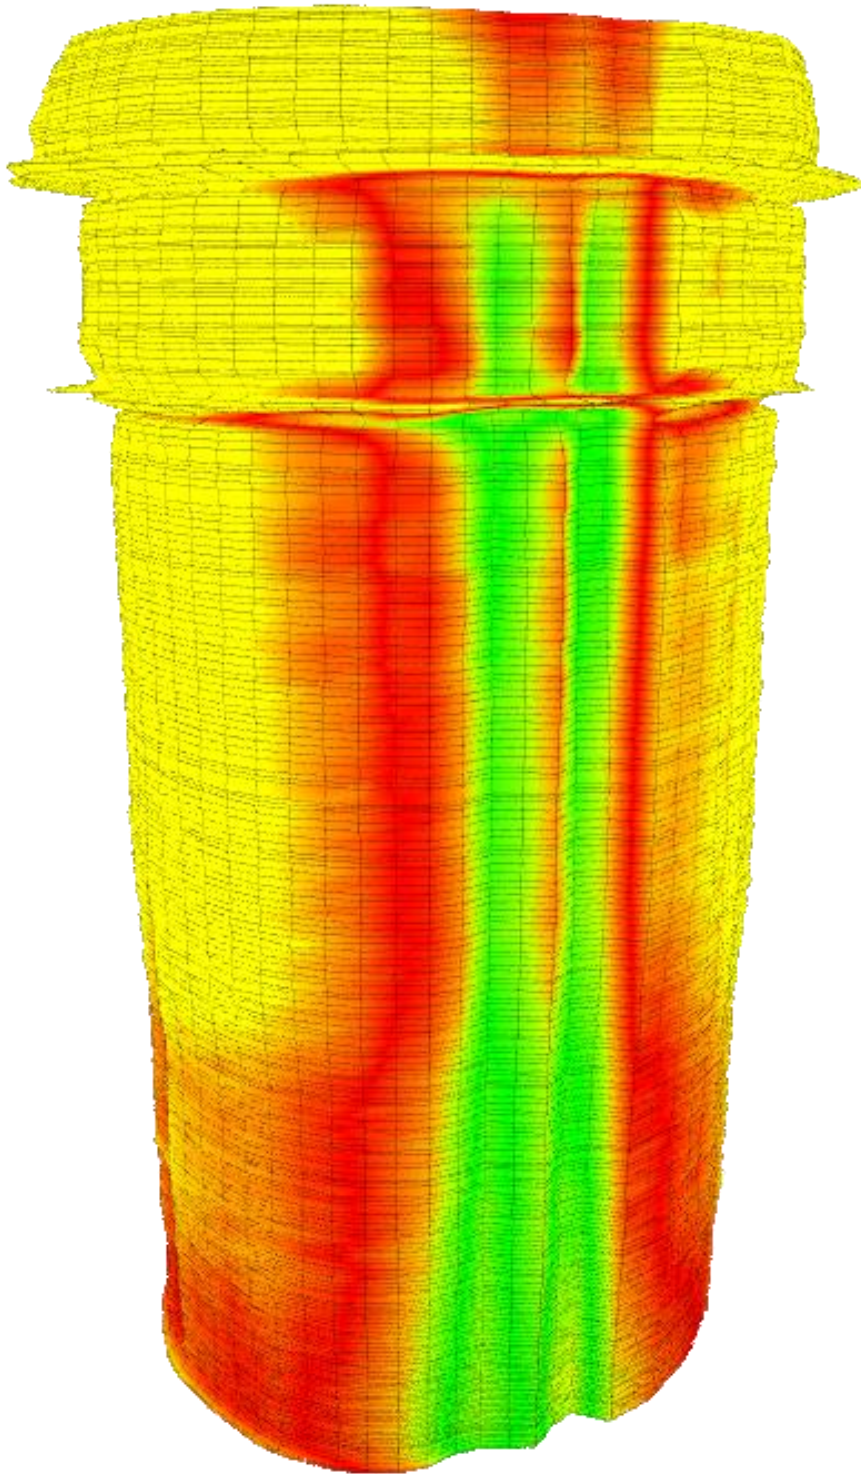
Liner1

The wear rate is normal but the wear pattern is unusual. Fwd direction (0°) shows low wear, usually a sign of excessive lubrication and a local peak, normally associated with a scratch. (Possibly protruding lub oil injector) – blue arrow. Monitoring recommended

In way of fuel injectors wear is low while above and below wear is high. Normal wear pattern is opposite like this. (see liner 2). We recommend to check the lub oil injection timing.

The maximum wear is not at the top piston ring (marked in grey) but lower. That is a sign for gas passage. (red arrow). We recommend to exchange the piston rings to increase sealing.

The high ovality may increase loads on piston rings and wear in piston ring grooves. We recommend to monitor the development.

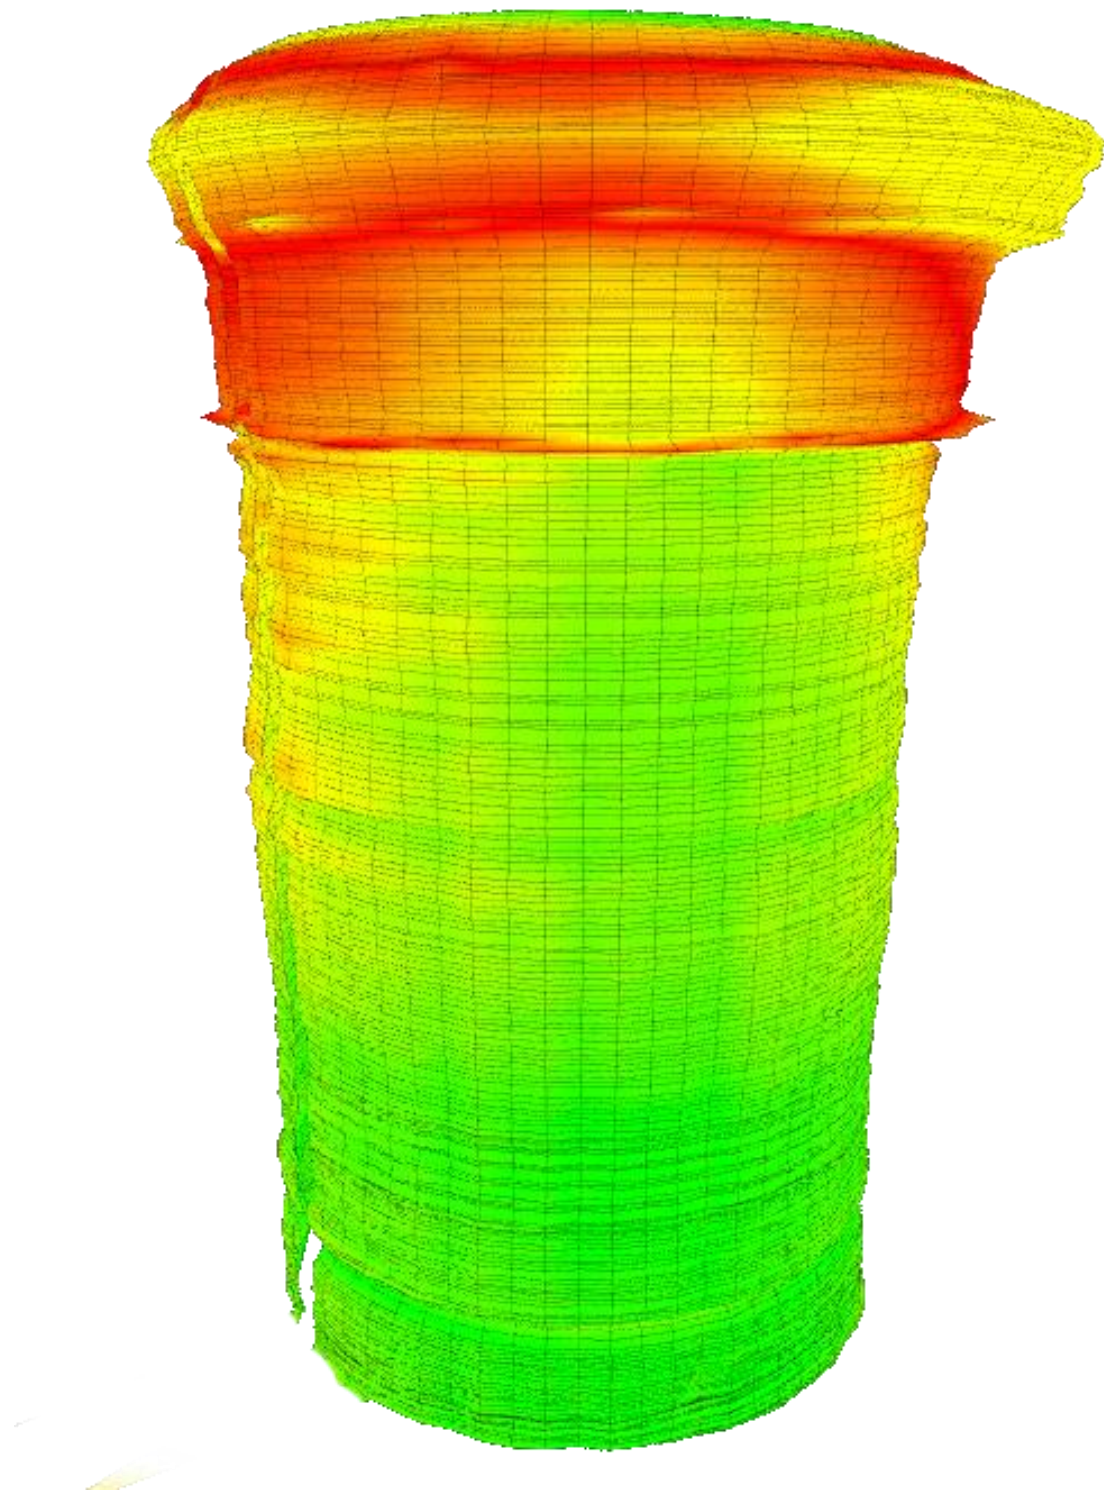
Liner 2

The wear rate is normal but the wear pattern is indicating increase wear in lower part.

All piston rings are leaking gas (red arrow). The gas mixing with lub oil may reduce lubrication thus increase wear. Only L7 shows some improved sealing in 270° direction.

The wear is increasing above the lub oil injectors while it should be reduced under normal circumstances. We recommend to check the lub oil injection timing and quantity. The injectors should be checked for blockage and proper function.

The wear has reached 75% of recommend limits. We recommend to monitor the development.

We recommend to exchange the piston rings and monitor the development.

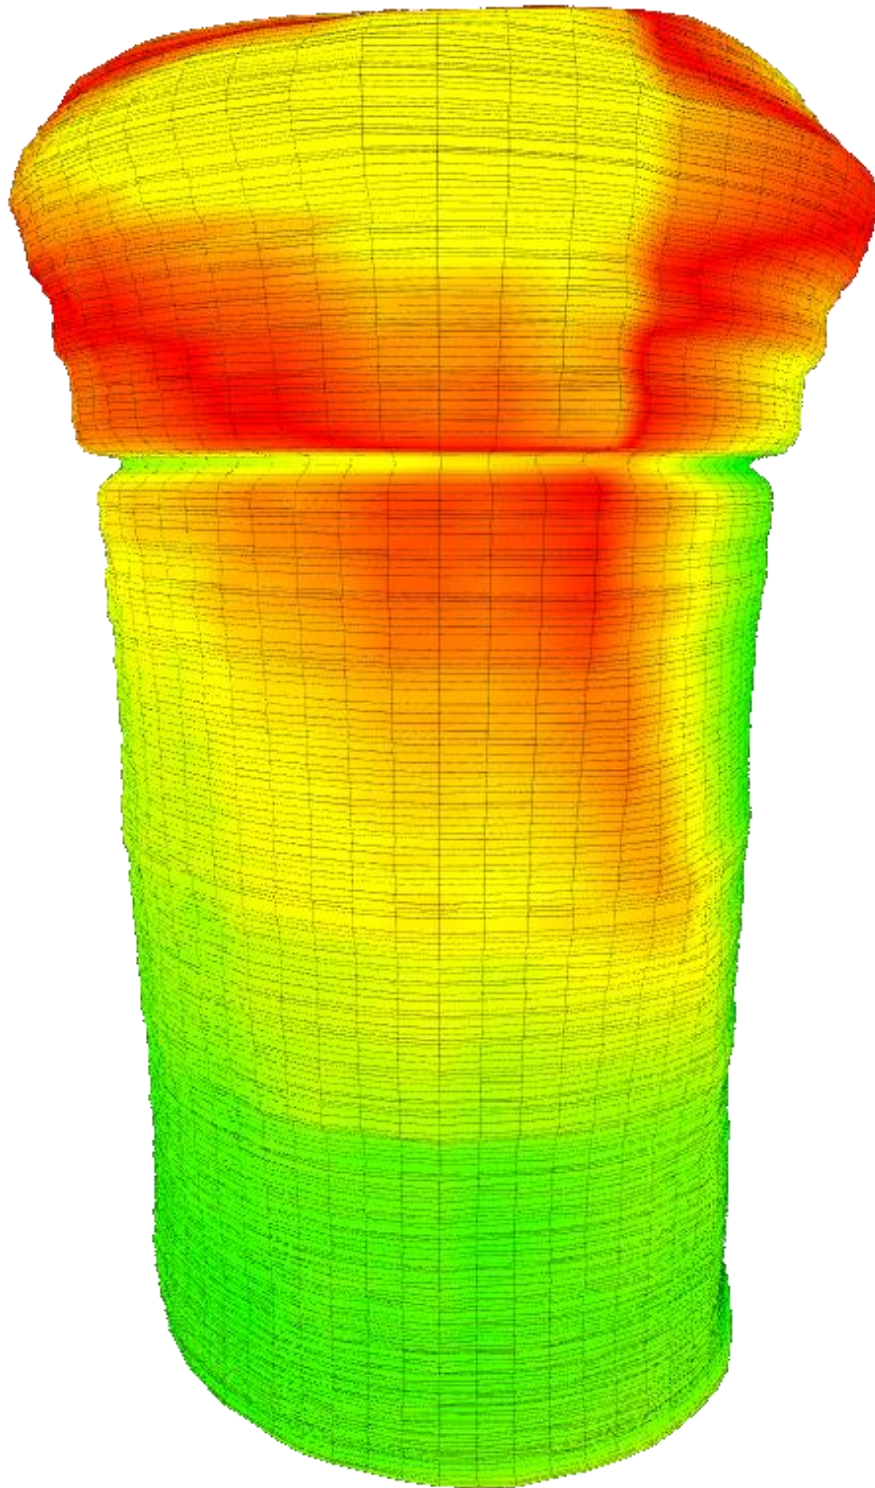
Liner 3

The wear rate is normal but the wear pattern is indicating high wear in lower part.

All piston rings are leaking gas (red arrow) and the oil rings on piston skirt appear to be sealing only. The gas mixing with lub oil may reduce lubrication thus increase wear.

The liner wear is approaching recommend limits. We recommend to prepare to exchange the liner.

We recommend to exchange the piston rings and monitor the development.

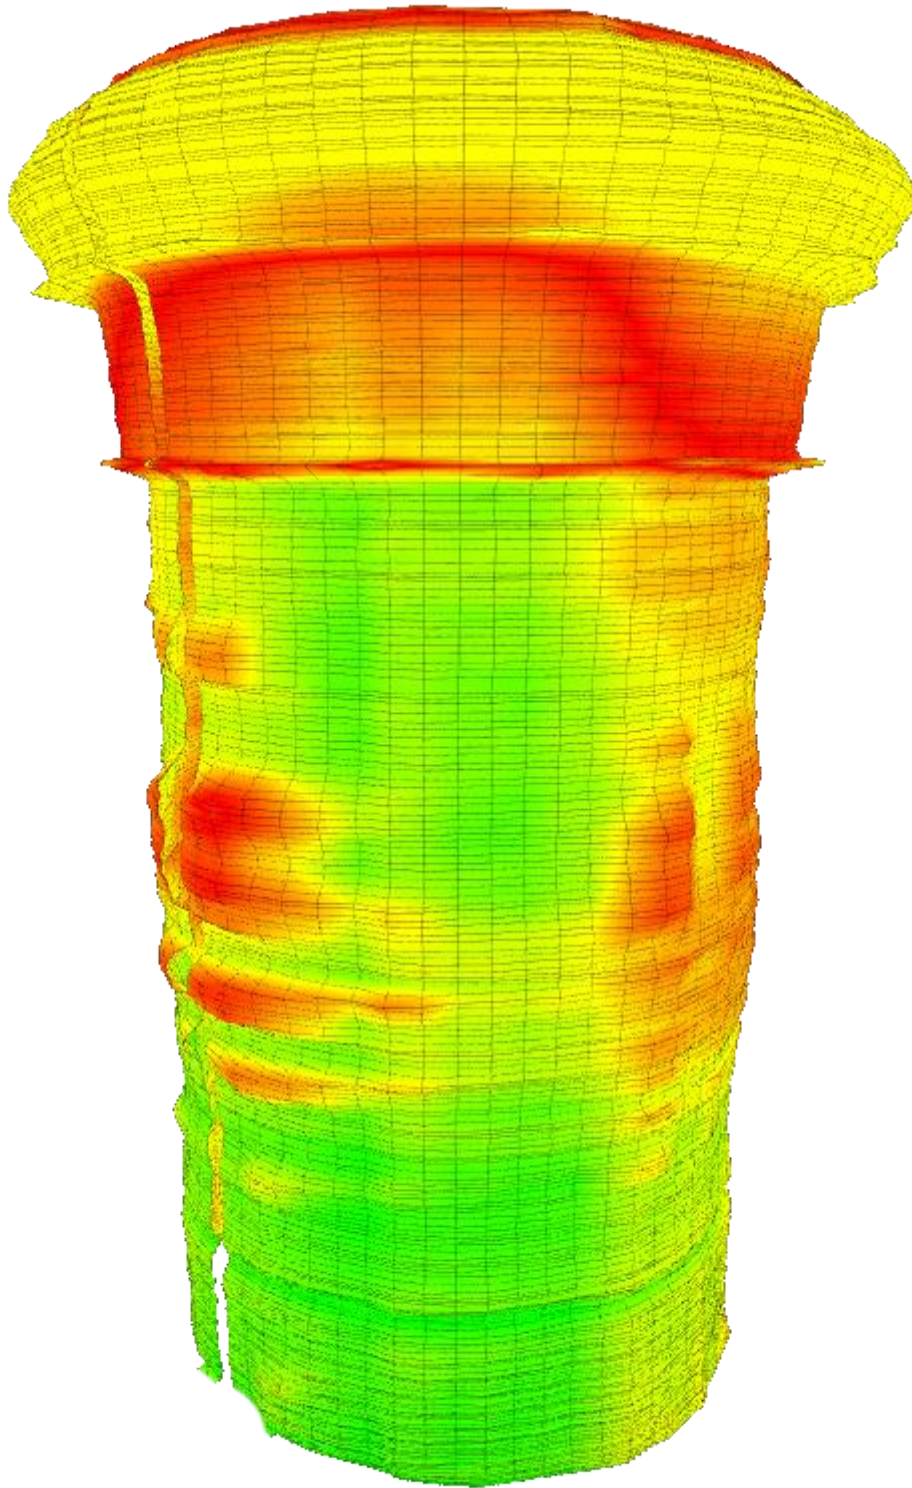
Liner 4

The wear rate is normal but the wear pattern is indicating increase wear in lower part. All piston rings are leaking gas (red arrow). The gas mixing with lub oil may reduce lubrication thus increase wear.

The wear is increasing above the lub oil injectors while it should be reduced under normal circumstances. We recommend to check the lub oil injection timing and quantity. The injectors should be checked for blockage and proper function.

The liner shows strong mechanical damages in mid stroke area – yellow arrows. Damage depth is up to 0.6mm. Considering the total wear pattern with gas leaks mechanical damages, we recommend to hone the liners at next possibility.

We recommend to exchange the piston rings and monitor the development.

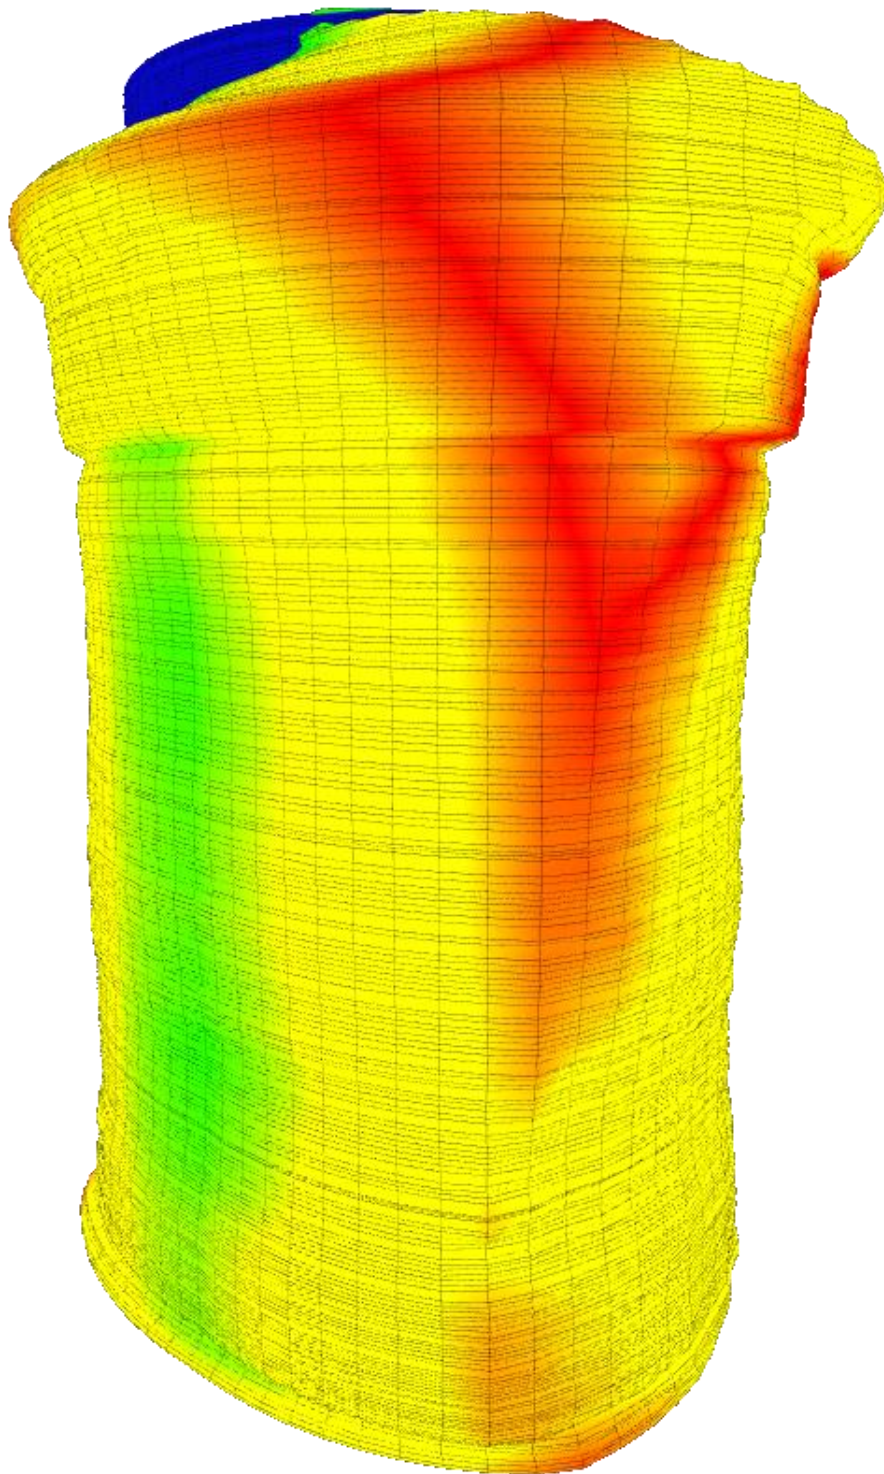
Liner 6

The wear and ovality is beyond recommended limits.

The top piston ring shows improved sealing – green arrow.

We recommend to exchange the liner.

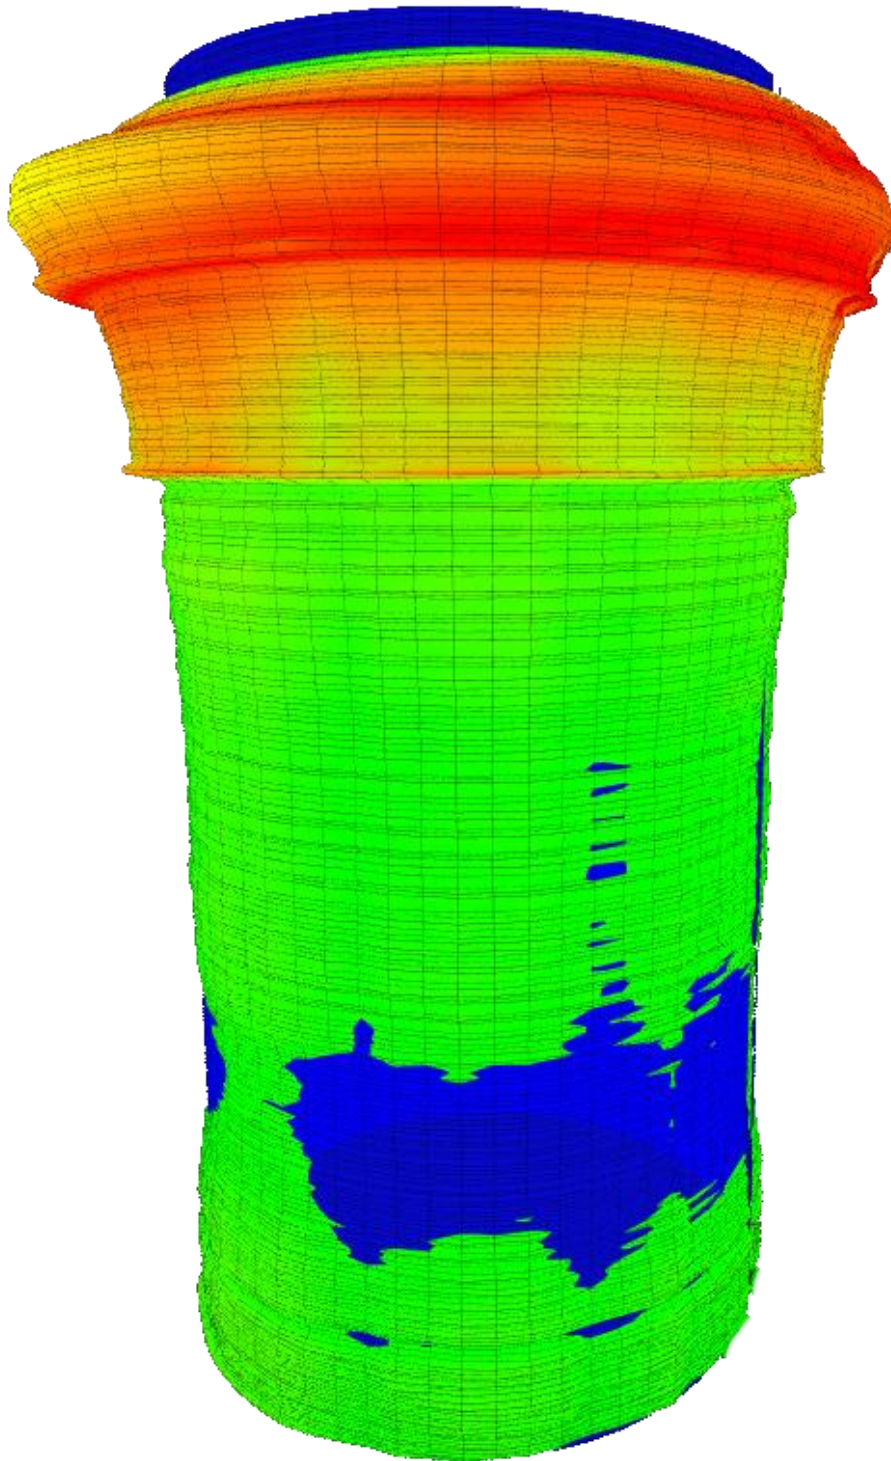
Liner 7

The wear pattern is that of a new liner. In way of the lower lub oil injection port the liner is protruding inward by about 0,1mm (yellow arrow), normally a sign of local mechanical damage corrected by grinding. This is considered uncritical, the pictures in range do not show any abnormal wear, although they do not cover the injector in question (PS injector/maneuver side).
