# Wear analysis of liner and piston rings

Name: Vessel 1  
 IMO:  
 Date:

Engine type: 6S70MC  
 Engine ID: :-)  
 Running hours: 43.081

# Wear analysis of liner - distribution

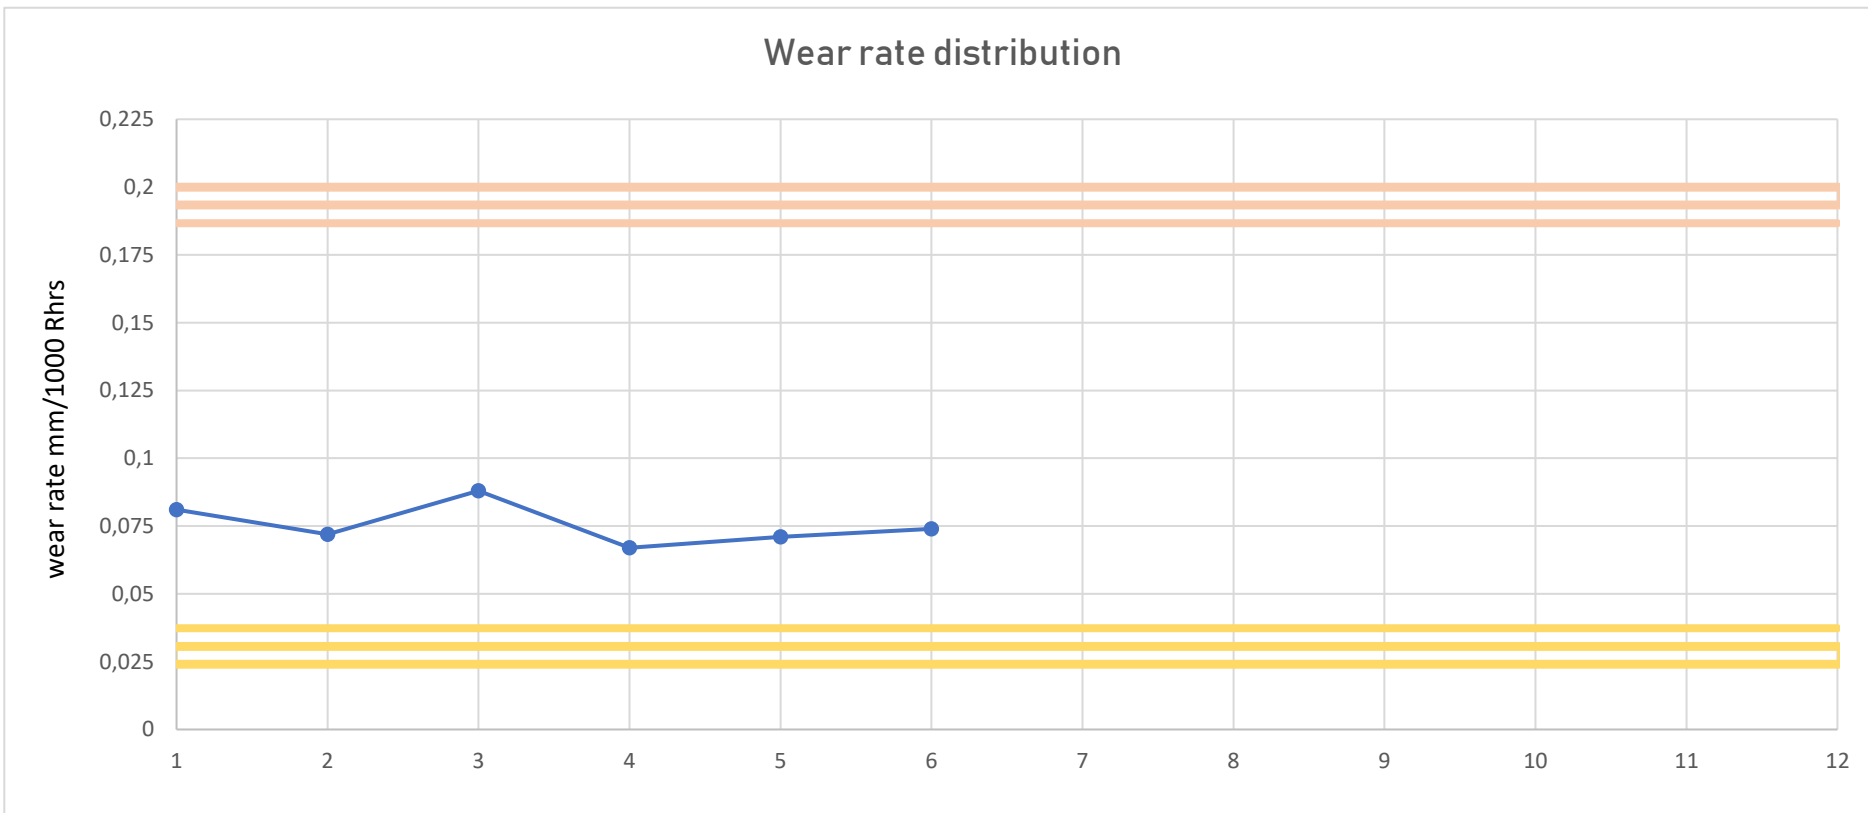
High wear rate warning **0,187** mm per 1000Rhrs

Low wear rate warning **0,037** mm per 1000Rhrs

liner D [mm]: 700

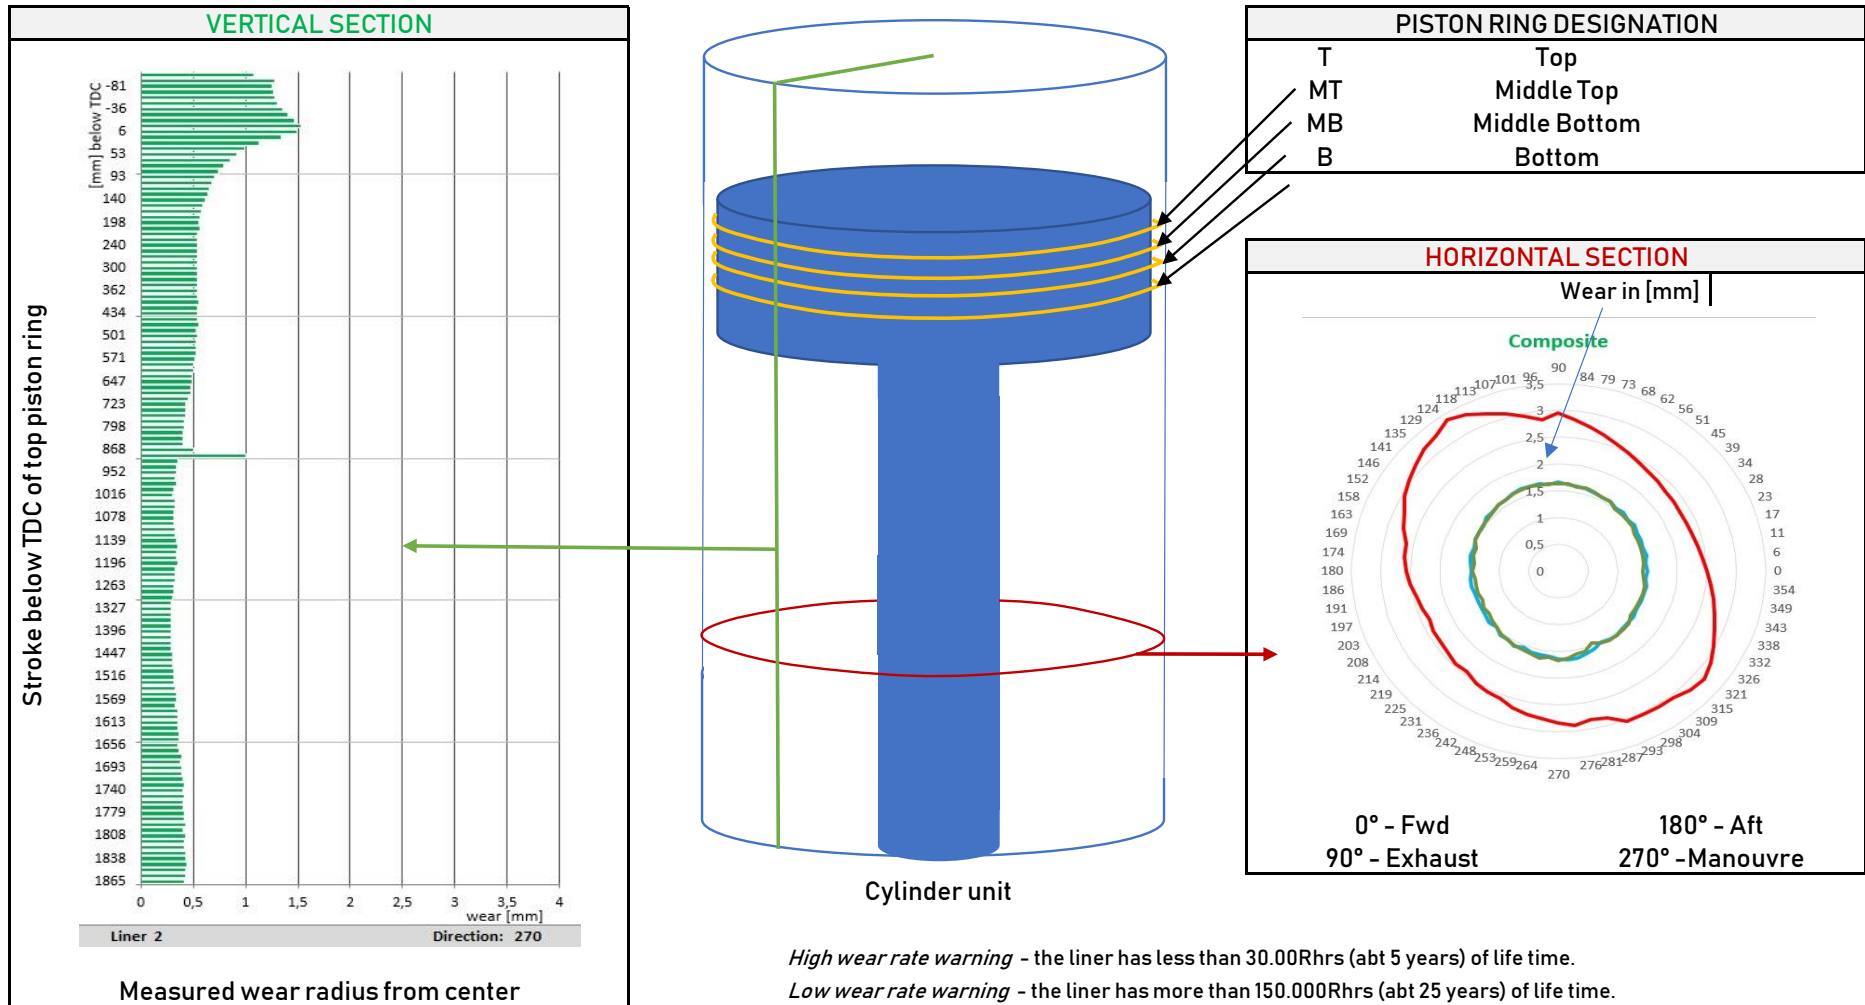
# Designations

Explanation of abbreviations used in the data sheets.

*High wear rate warning* - the liner has less than 30.00Rhrs (abt 5 years) of life time.  
*Low wear rate warning* - the liner has more than 150.000Rhrs (abt 25 years) of life time.

*Resolution:* All measurements have a resolution of 0.01mm  
*Precision:* All measurements have a statistical error of +/- 0.02mm.

*Temperature compensation:* All measurements are compensated for liner and gauge temperature.
